Bosworth Creek Water Quality
Data Study:

Final Report

Collins, L.A., C.D. Murray and R.T. Stainton. 2011.
Bosworth Creek Water Quality Data Study: Final Report
Environmental Studies Research Funds Report No. 185. Oshawa, ON. 69 p.

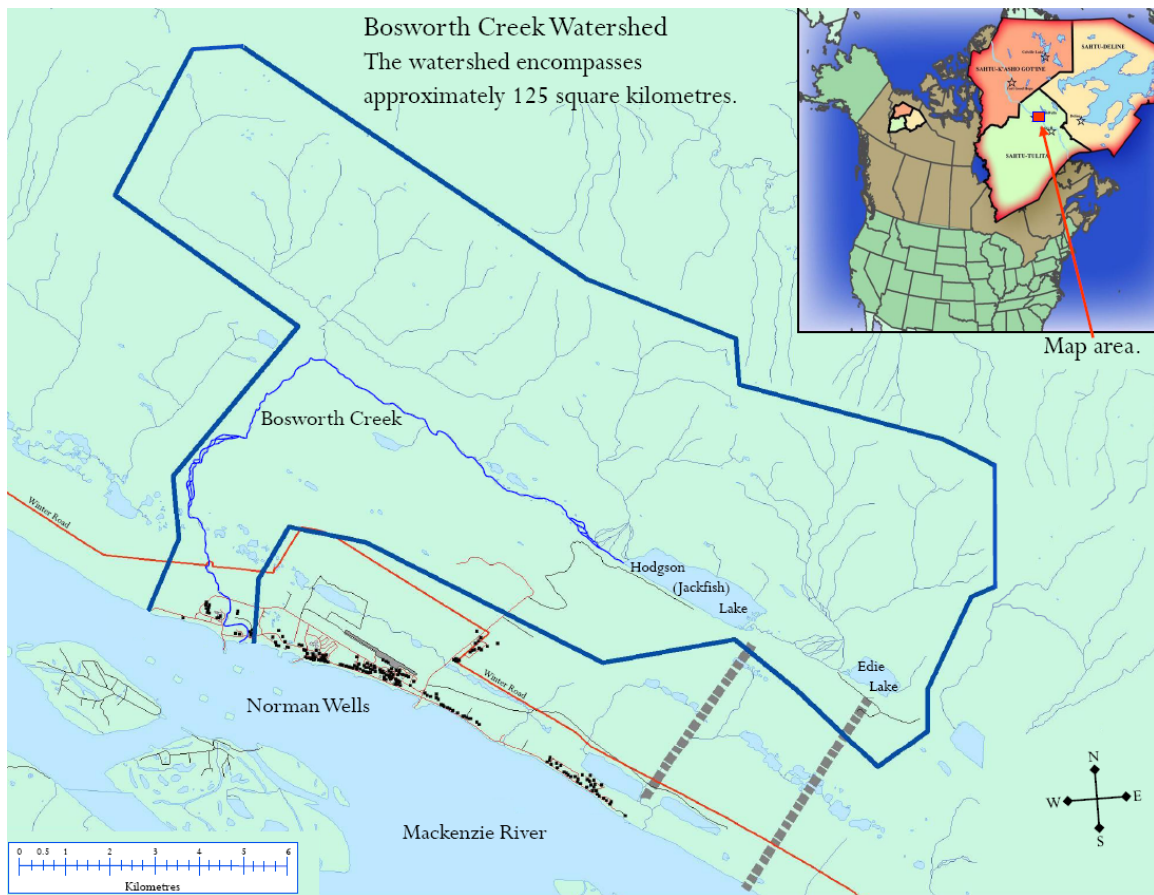
Figure 1. Bosworth Creek Watershed (Guthrie, 2009a)

Bosworth Creek (Tulita District, Sahtu Settlement Area, Northwest Territories) ($65^{\circ} 18'N$ $126^{\circ} 41'W$) drains a small watershed of ~ 125 sq. km. and originates as the outlet of Jackfish (Hodgson) Lake. From Jackfish Lake the creek runs northwest for approximately 8 km, paralleling the base of Discovery Ridge in the Norman Range of the Franklin Mountains and turns sharply to run southeast toward the town of Norman Wells, NWT, draining into the Mackenzie River within the town boundaries (Figure 1).

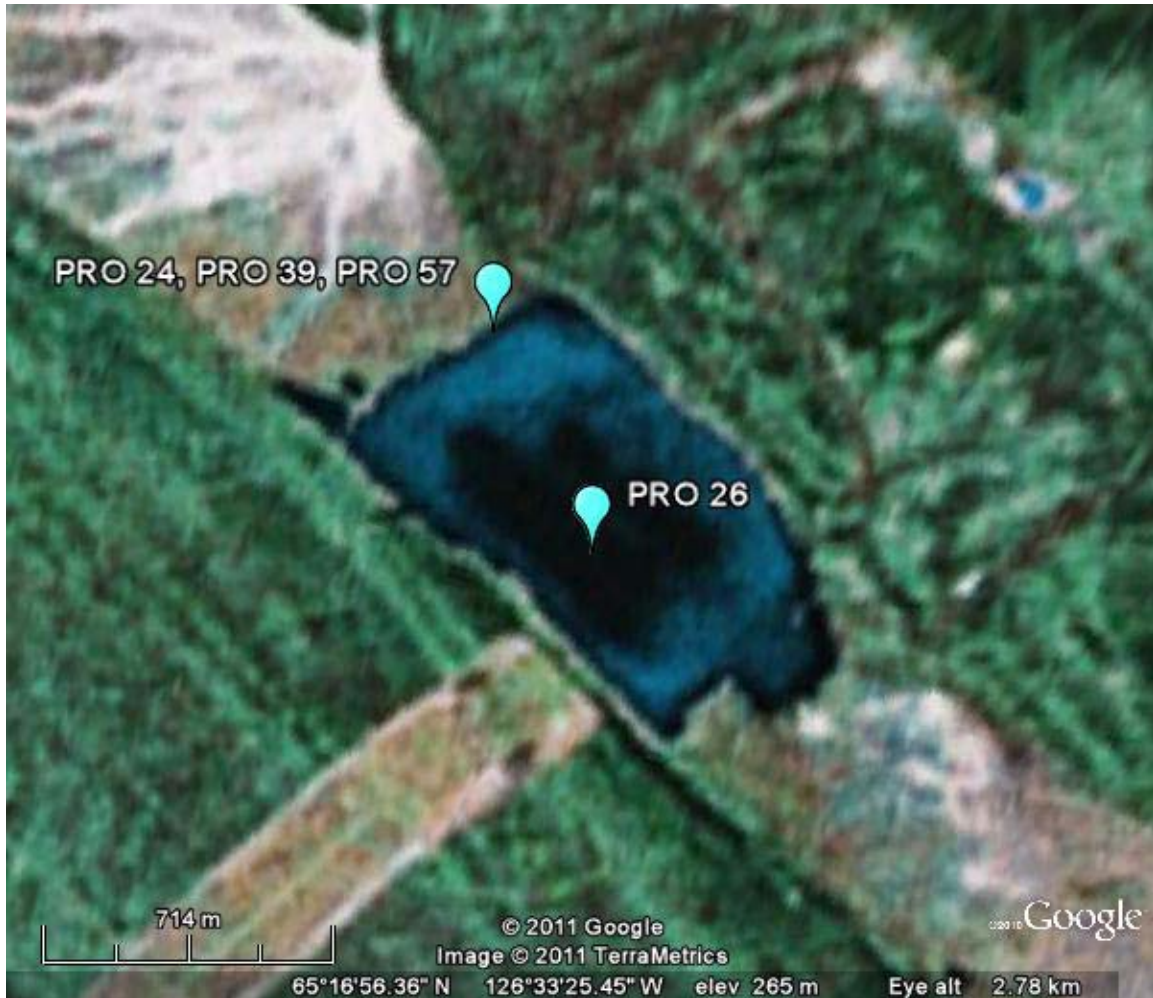
Figure 5. Edie Lake site sample location (Image Source: Google Earth, 2011)

Edie Lake is one of two headwater lakes for the Bosworth Creek Watershed. It is the uppermost water body in the watershed. The lake is situated at the base of the Discovery Ridge in the Norman Range. There are few streams providing direct input into the lake with a confluence of streams entering the watershed at the outlet of the lake. Groundwater flow into the lake has been reported in SENES and Guthrie (2009). This 2009 report indicates that the water quality of Edie Lake has undergone a drastic change in pH and water quality over the last 20 years. SENES and Guthrie (2009) report a change in pH from 10.2 to 7.8 over this time period. The pH value of 7.61 (March 6, 2008) from Edie Lake is the lowest reading recorded in the existing Bosworth Creek data. There are four samples in the data set from Edie Lake, from fall 2007, winter and fall 2008, and fall 2009 (Figure 5); however, there is inconsistent analysis for chemical and physical parameters. The changes in basic water chemistry that were noted over time, with the reported change in aquatic life, would make this site a priority for continued water quality monitoring in a long-term monitoring program.

Table 6 shows the chemistry data from this site that exceeds either the GCDWQ or GPAL guidelines. The only water quality parameter that exceeds the GCDWQ at this group of sampling sites is sulphide. One sample taken from the middle of Edie Lake (PRO 26) on March 6, 2008 had a sulphide concentration of 2.64 mg/L, substantially higher than the ≤ 0.05 mg/L drinking water quality guideline. However, a sample taken six months later on September 6, 2008 on the northwest shore of Edie Lake (PRO 39) had a sulphide concentration of 0.003 mg/L, within acceptable standards for drinking water.

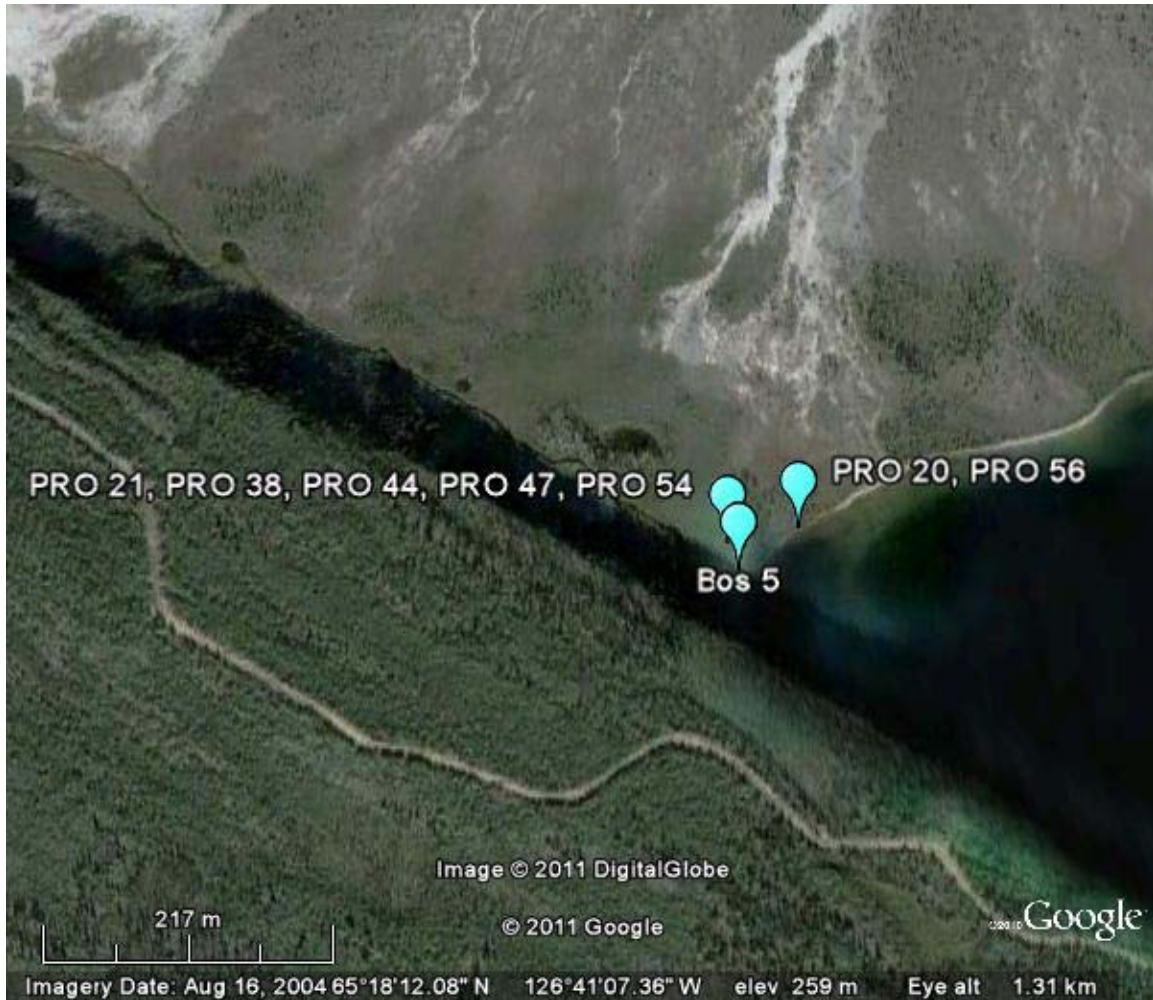
Figure 6. Jackfish Lake Sample locations (Image Source: Google Earth, 2011)

A total of eight samples were taken at Jackfish Lake, with the sample locations close to the outlet of Bosworth Creek (Figure 6). Jackfish Lake is downstream from Edie Lake and receives water from this water body as well as numerous tributaries that enter the watershed upstream, which drain through low, wetland type habitat. The eight samples from Jackfish Lake are recent samples from the years 2007-2009, with five samples for the year 2009. One of these samples was not part of the BCMP and was sampled by INAC in 2009 (Guthrie, pers. comm.). No exceedances of the GPAL and GCEWQ were noted at this site.

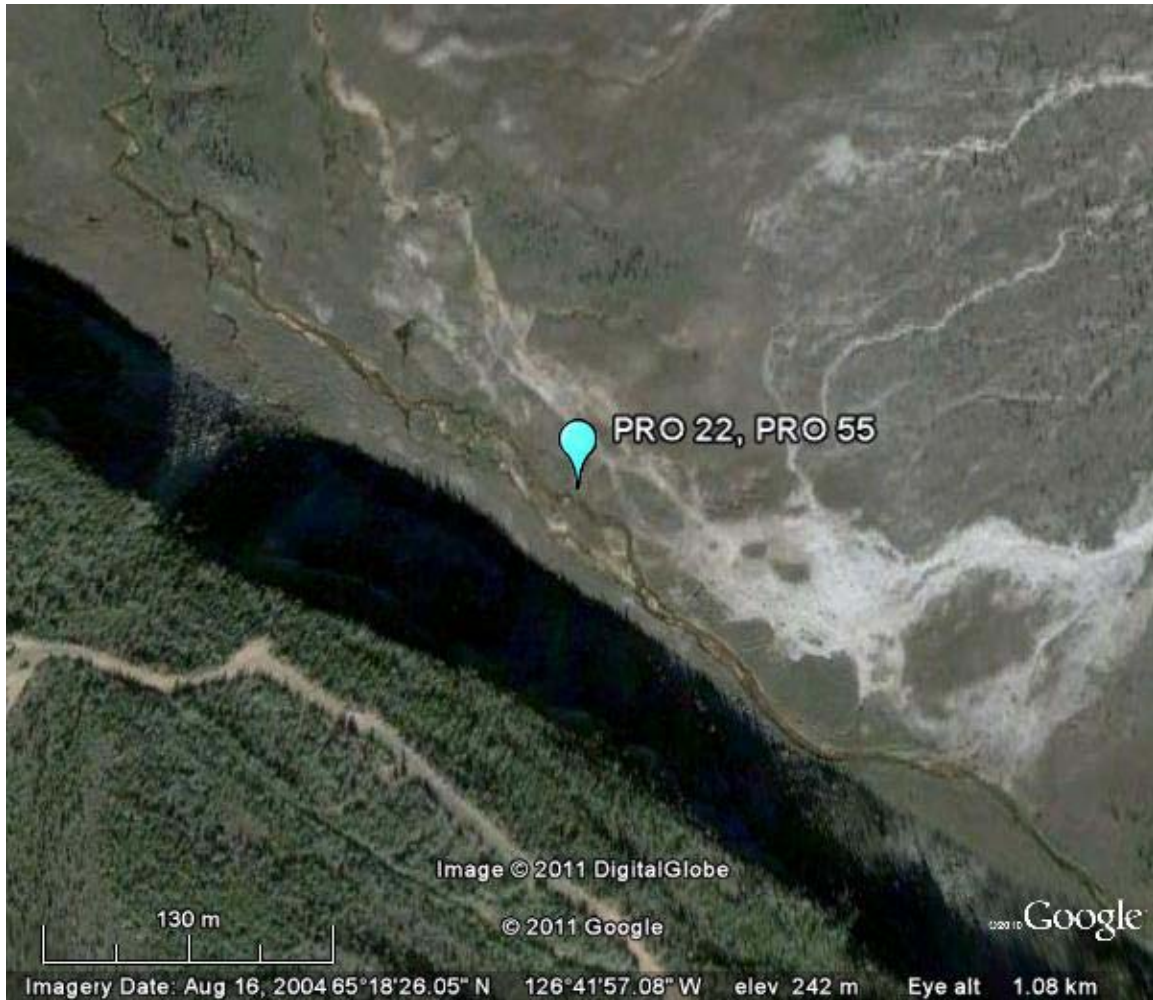
Figure 7. Downstream of Jackfish Lake sample locations (Image Source: Google Earth 2011)

There are two samples from downstream of Jackfish Lake (Figure 7). Sampling at this location was done for metals and basic physical parameters in September of 2007 and September of 2009 (PRO 22, PRO 55). This sampling location is located downstream of a large area of channels and gullies that drain the Discovery Ridge. Significant erosion from the ridge is apparent from the satellite image of this location (Figure 7).

Table 7 shows the chemistry data from this site that exceeds either the GCDWQ or the GPAL. Sample PRO 22, taken on September 2, 2007, exceeds the GPAL for mercury, and equals the GPAL for silver. Mercury concentrations were 0.00004 mg/L, above the guideline of 0.000026 mg/L. The sample taken two years later at the same site (PRO 55) reported mercury at below the detection limit; however, the reported detection limit was much higher at 0.0001 mg/L. Silver concentrations in sample PRO 22 were 0.0001 mg/L, which is equal to the recommended GPAL. Sample PRO 55 that was taken two years later at the same site had silver concentrations below the detection limit.

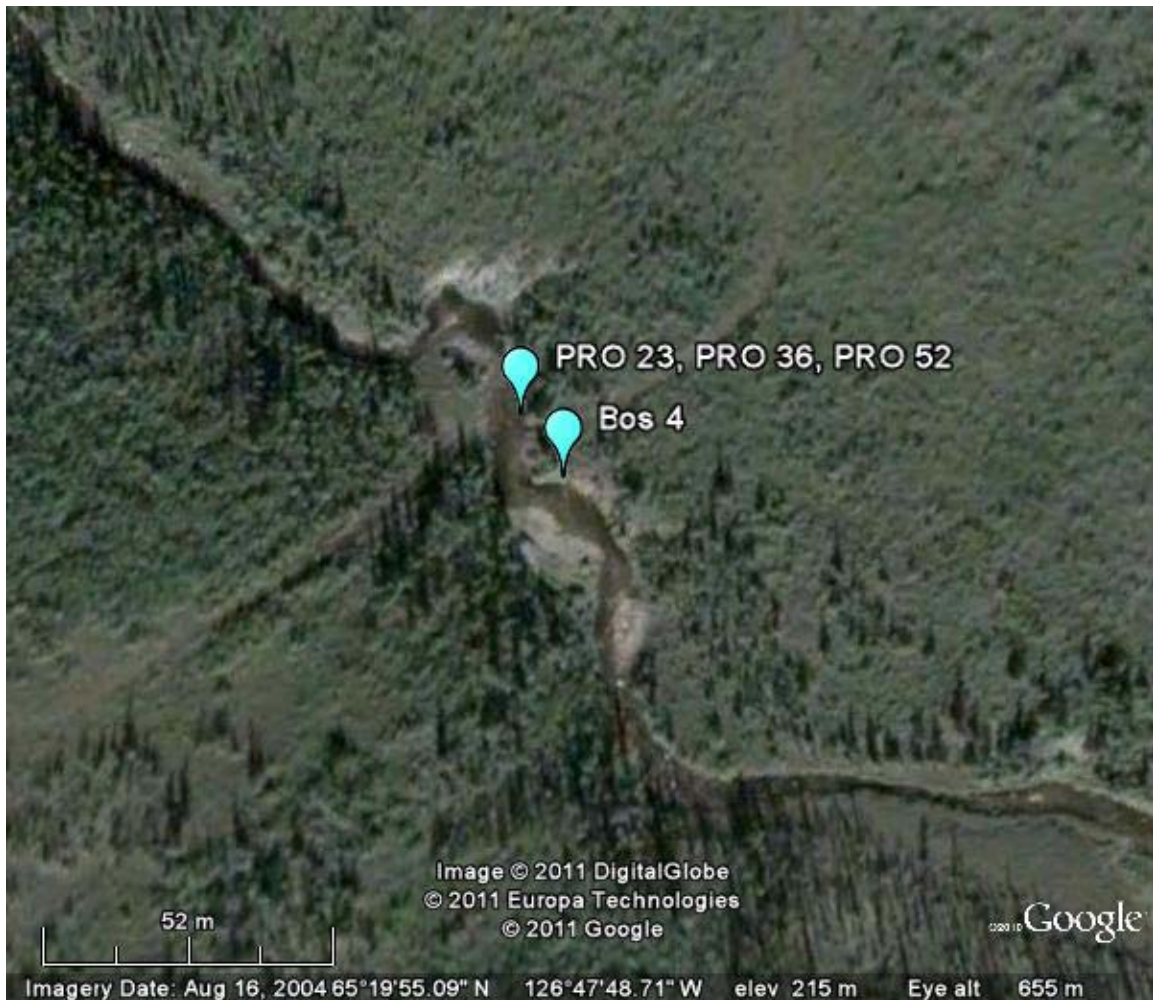
Figure 8. Terrain Vehicle Crossing sample locations (Image Source: Google Earth 2011)

There are a total of four samples taken from the All Terrain Vehicle Crossing site (Figure 8). Three of these samples are from the BCMP (PRO 23, PRO 36 and PRO 52) and one sample upstream of the actual crossing through INAC in 2009. All samples were taken between September 2007 and September 2009. Concern over bank erosion, alteration to the stream channel and destruction of habitat at this location are noted in SENES and Guthrie (2009) and Northern Cumulative Impact Monitoring Program (2008). Sampling at this site is also inconsistent for all metals and other physical and chemical parameters. There are no exceedances of the GCDWQ or GPAL at this site.

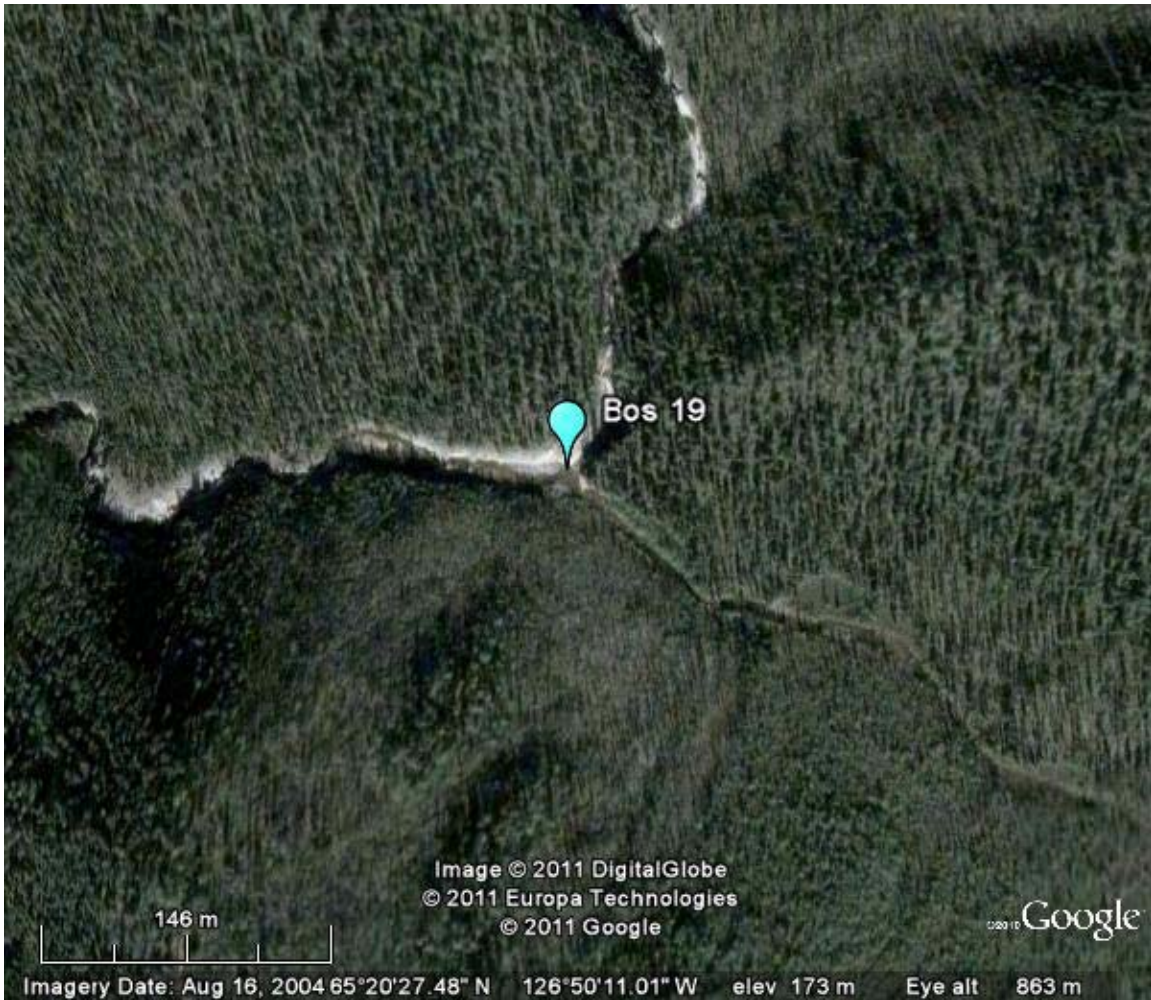
Figure 9. Tributary Confluence, Upper Creek sample location (Image Source: Google Earth 2011)

INAC sampled one time in 2009 (Bos 19) at the confluence of the main channel of Bosworth Creek and the major unnamed tributary stream draining the ridge that joins Bosworth Creek at the base of the Discovery Ridge (Figure 9). Data from this site are included in the overall and longitudinal statistical analyses. However, within the limited data from this site, there are no exceedances of the GCDWQ or GPAL.

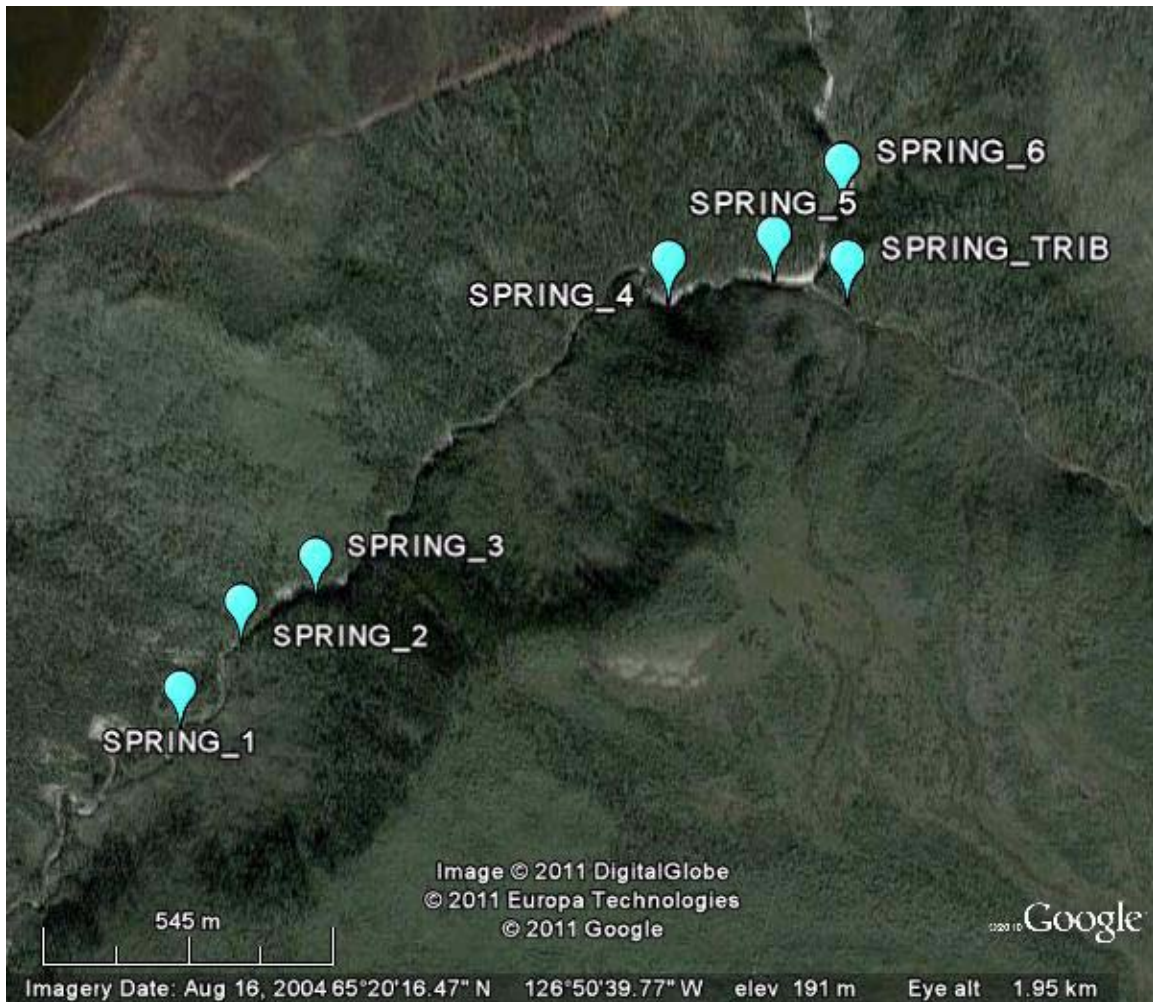
Figure 10. Upper Creek Spring Sites sample location (Image Source: Google Earth 2011)

The BCMP has sampled several “spring” sites upstream and downstream of the confluence of the main Bosworth Creek channel and the stream draining the ridge (Figure 10). There are only basic field measurements of temperature, dissolved oxygen and conductivity for these sites. These data were used to assess general trends to characterize these sites in the context of others in the watershed; however, since total water chemistry for these water sources was not measured, the samples are excluded from any statistical analysis of the creek water, and no comparison to the GPAL and GCDWQ is possible.

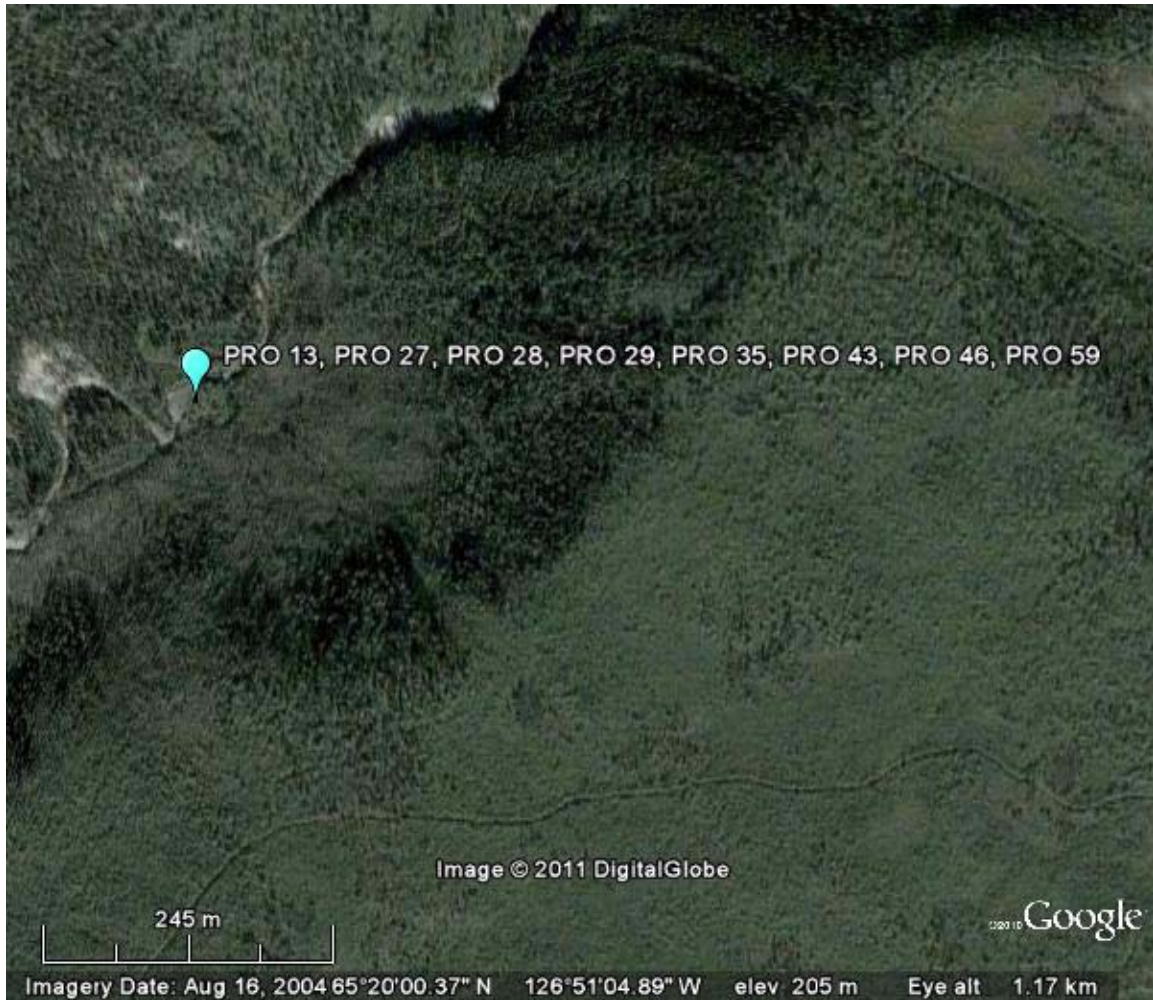
Figure 12. Third Firebreak site sample location (Image Source: Google Earth 2011)

Eight water samples were collected from the Third Firebreak site between 2007 and 2009 (PRO 13, PRO 27, PRO 28, PRO 29, PRO 35, PRO 43, PRO 46, PRO 59) (Figure 12). The site is located midway along the creek channel in a wooded valley section. The samples at this site are all part of the BCMP. This site had several exceedances of the GCDWQ and GPAL.

Table 8 shows the chemistry data from this site that exceeds the GCDWQ and/or the GPAL. Two of seven samples that were analyzed for aluminum concentrations exceeded the 0.1 mg/L GPAL. Samples PRO 29 and PRO 46 had aluminum concentrations of 0.325 mg/L and 0.965 mg/L, respectively. Pro 29, one of the six samples that were analyzed for mercury, had a concentration of 0.002 mg/L, above the 0.000026 mg/L GPAL and the 0.001 mg/L GCDWQ. The other five samples had mercury concentrations below the detection limits. Two samples of seven, PRO 13 and PRO 29, had selenium concentrations higher than the 0.001 mg/L GPAL, with 0.003 mg/L and 0.0026 mg/L, respectively. Four of the seven samples analyzed for selenium had a concentration less than the detection limit, and therefore statistics such as mean and median could not be calculated. One of the seven samples tested for silver (PRO

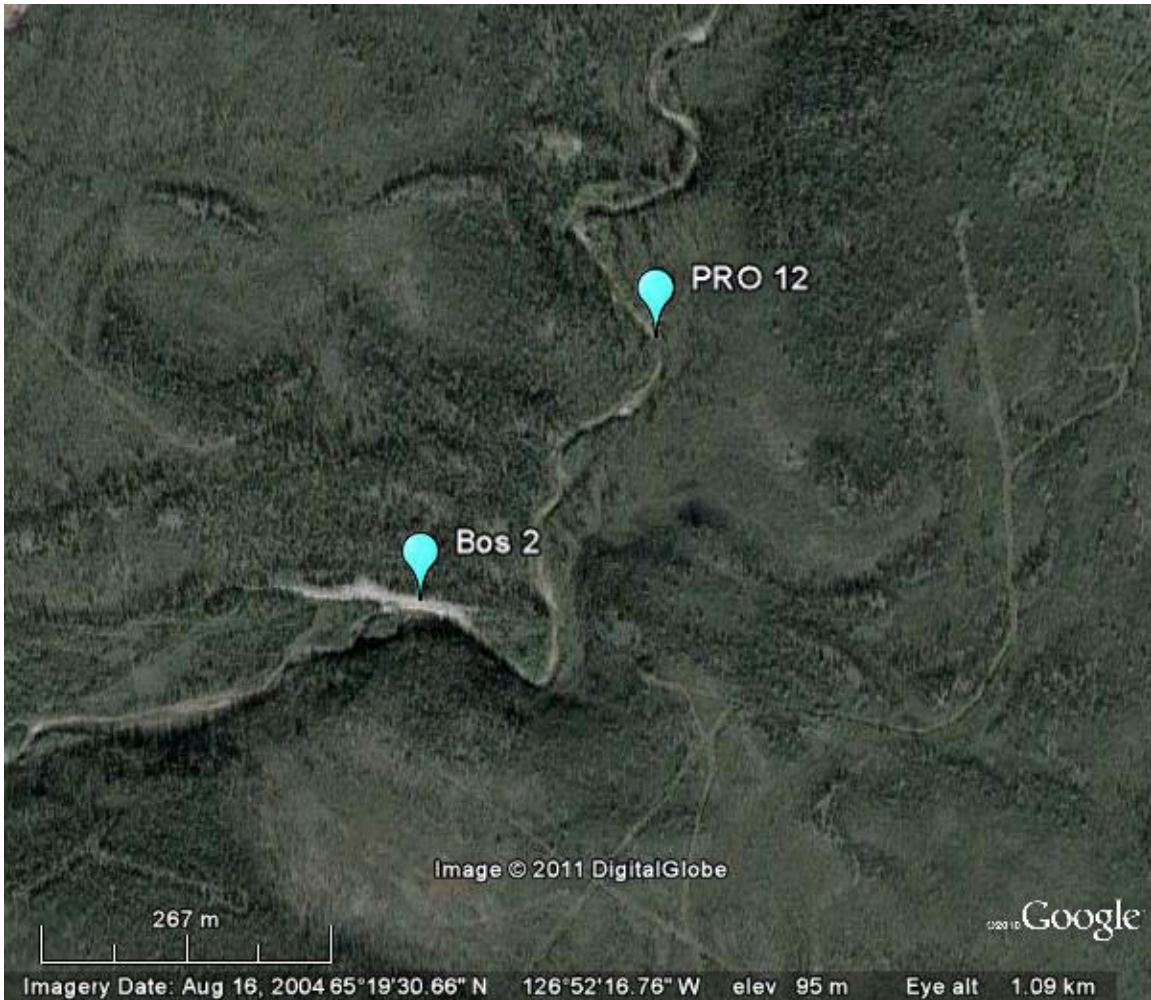
Figure 13. Second Fire Break site sample locations (Image Source: Google Earth 2011)

There were two water samples collected at this site (Figure 13). Sample PRO 12 was taken in March of 2007 as part of the BCMP, and sample Bos 2 is an INAC sample taken in August of 2009. This area is located approximately 1.5 km downstream of the third firebreak site.

Table 9 shows the chemistry data from this site that exceeds either Heath Canada’s GCGDWQ or the GPAL. There was only one exceedance of the GPAL at this site. Sample PRO 12 had a selenium concentration of 0.0017 mg/L, above the 0.001 mg/L guideline. There were also two exceedances of the GCDWQ, as sample PRO 12 was positive for both coliforms and *E. coli*.

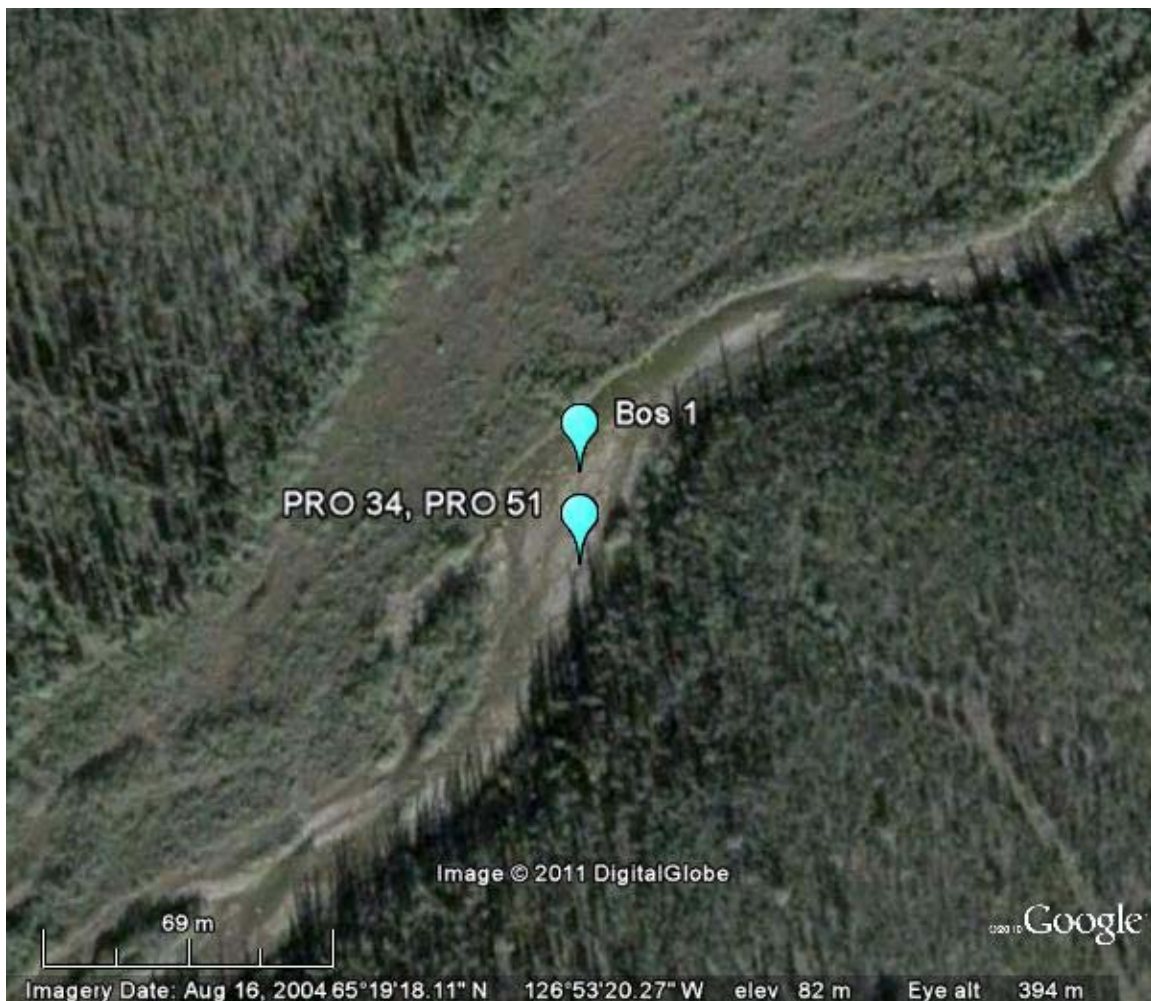
Figure 14. First Firebreak site sample locations (Image Source: Google Earth 2011)

These samples are located approximately 1.3 km downstream from the second firebreak site. Sampling was done on September 1 in both 2008 and 2009 (PRO 34 and PRO 51, respectively). This site has been grouped with the INAC Bos 1 site as the two sites are in very close proximity to one another (Figure 14). Bos 1 sample is a fall sample taken in August 2009. This site is located in a region of the stream where the topography is flatter and the channel becomes braided. The limited data that is available from this site has no exceedances of the GCDWQ or GPAL.

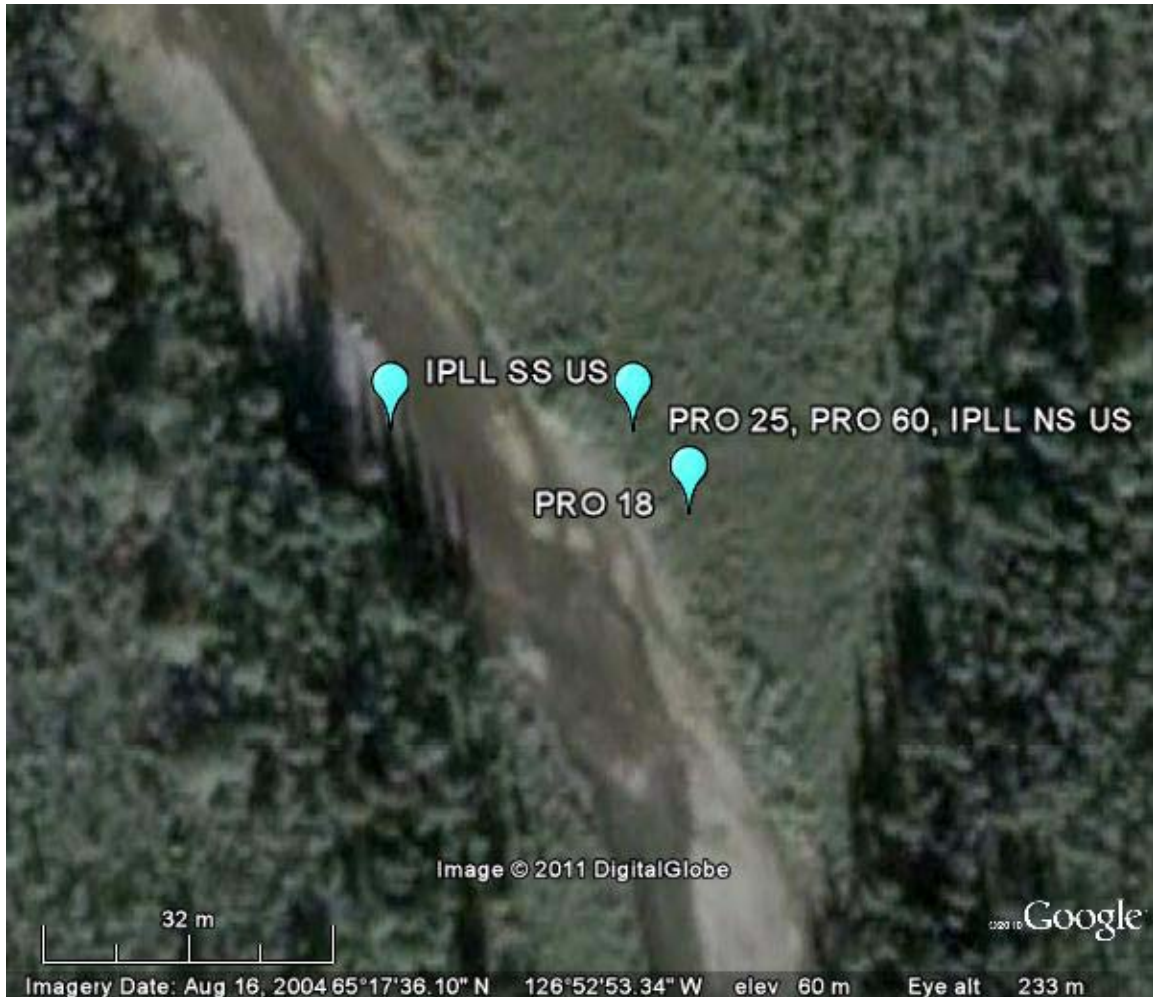
Figure 16. Upstream of Pipeline site sample locations (Image Source: Google Earth, 2011)

There are six samples from sites upstream of the Norman Wells to Zama pipeline crossing (Figure 16). Historic samples with site descriptions only (no coordinates) taken by the Interprovincial Pipeline Limited Study (Interprovincial Pipeline (NW) Ltd. 1985) are included (IPLL NS US and IPLL SS US). One INAC site is located approx. 0.6 km downstream of the winter road site (Bos 23). This site has been included with three samples from the BCMP (PRO 18, PRO 25 and PRO 60) upstream of the Norman Wells

to the Zama pipeline crossing. The IPLL sites are from August 1985, two BCMP samples are from fall of 2007 and 2009, and the INAC sample is from summer of 2009. They were considered together for statistical analysis.

Table 10 shows the chemistry data from this site that exceeds the GCDWQ. There were no exceedances at this site of the GPAL. There were two exceedances of the GCDWQ's microbial contaminants. Sample PRO 25 tested positive for both Total coliforms and *E. coli*.

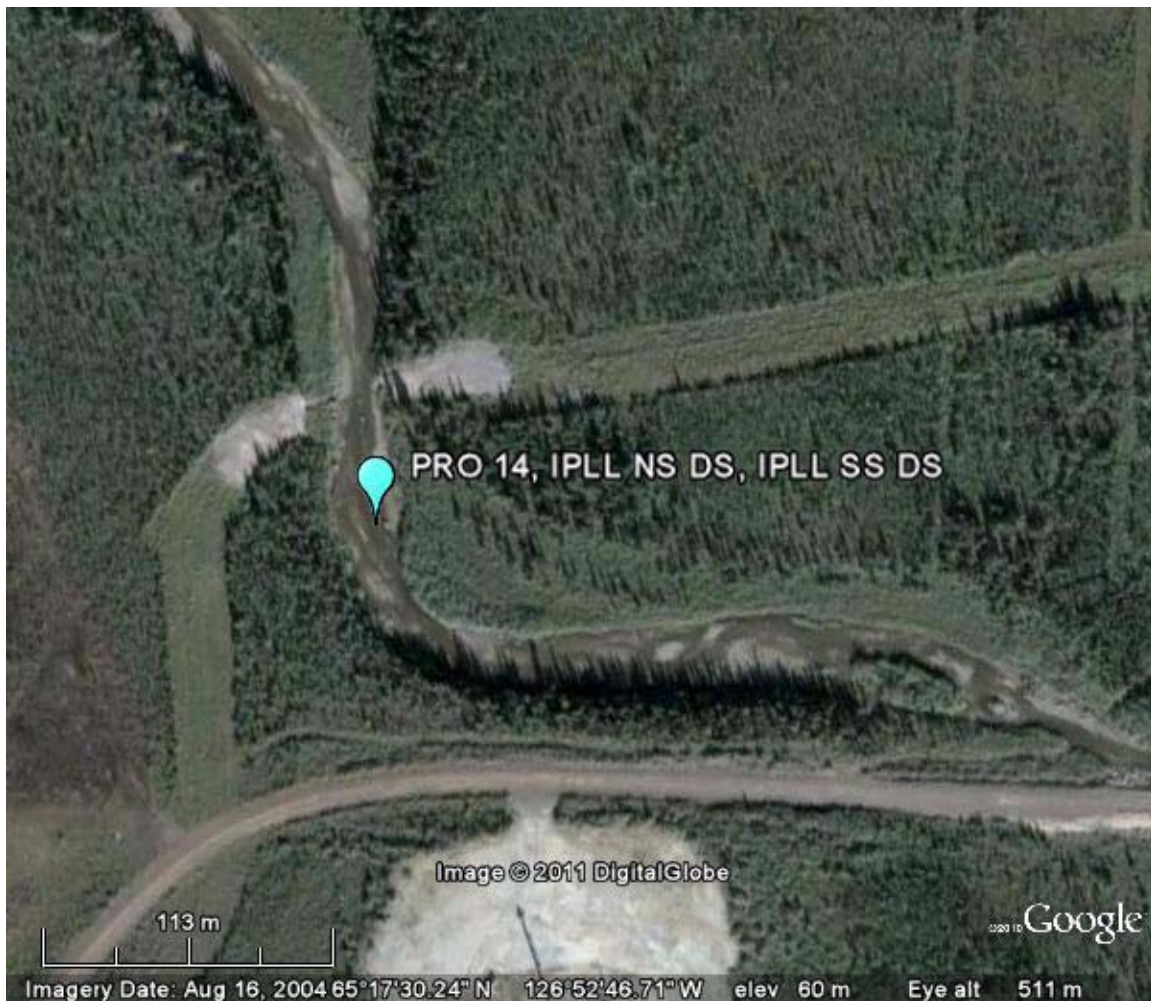
Figure 18. Downstream of Pipeline Crossing site sample location (Image Source: Google Earth 2011)

Four sample sites are located just downstream of the pipeline crossing (Figure 18). One of these samples (Unit 1) has been identified as being a sediment sample while labelled a water sample. The sample was removed from the water quality analysis. Of the three remaining samples, two are identified as being collected in August 1985 30 metres downstream of the pipeline for the IPLL study (IPLL NS DS and IPLL SS DS). One BCMP sample for this location is Pro 14, sampled in the summer of 2007.

Table 12 shows the chemistry data from this site that exceeds the GPAL. There were no exceedances of the GCDWQ at this site. Sample PRO 14, taken on June 30, 2007, had a selenium concentration of 0.0031 mg/L, which exceeded the selenium GPAL of 0.001 mg/L.

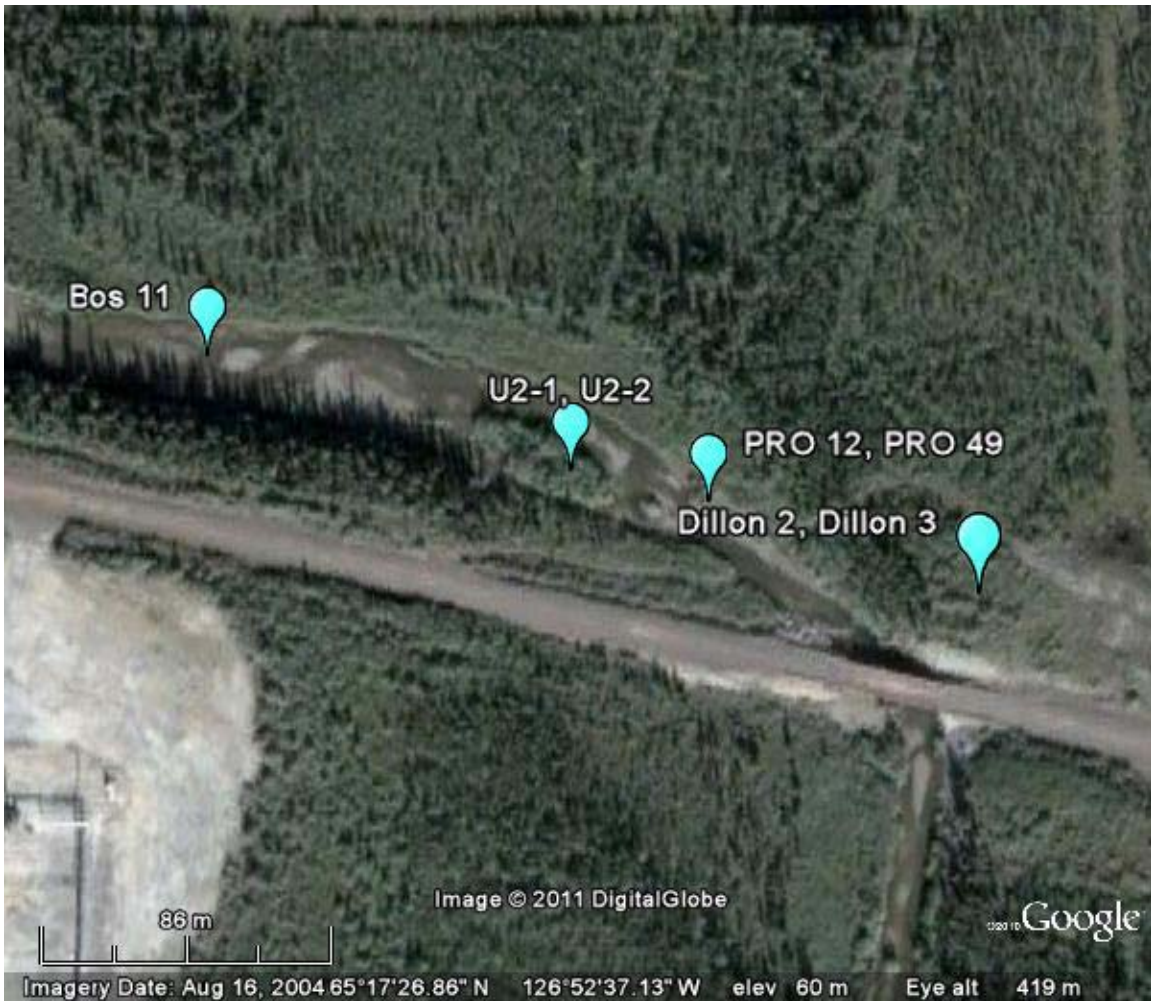
Figure 19. Upper Bridge North site sample locations (Image Source: Google Earth 2011)

There are a total of seven Upper Bridge North samples in the database (Figure 19). Samples are from the summer and fall of 1978 (Dillon 2, Dillon 3), fall of 2006 (U2-1, U2-2), and summer of 2007 and 2009 (PRO 15, PRO 49) and one INAC sample from summer 2009 (Bos 11). These samples are grouped together as they fall between the pipeline samples and the upper bridge.

Table 13 shows the chemistry data from this site that exceeds the GCDWQ and/or the GPAL. The aluminum concentration in sample PRO 49 (0.203 mg/L) that was taken on July 24, 2009 exceeds the guidelines for both GCDWQ and GPAL, which are both set at 0.01 mg/L. The two other samples that were analyzed for aluminum in 1978 (Dillon 3) and 2007 (PRO 15) at the Upper Bridge North location did not exceed the detection limits. The Dillon 3 sample that was taken in September of 1978 has an arsenic concentration of 0.01 mg/L. This value is equal to the maximum allowable concentration for arsenic in the GCDWQ, and exceeds the 0.005 mg/L GPAL. Two other samples at this location were analyzed for arsenic (PRO 15 and PRO 49), but both were below the detection limits for this element.

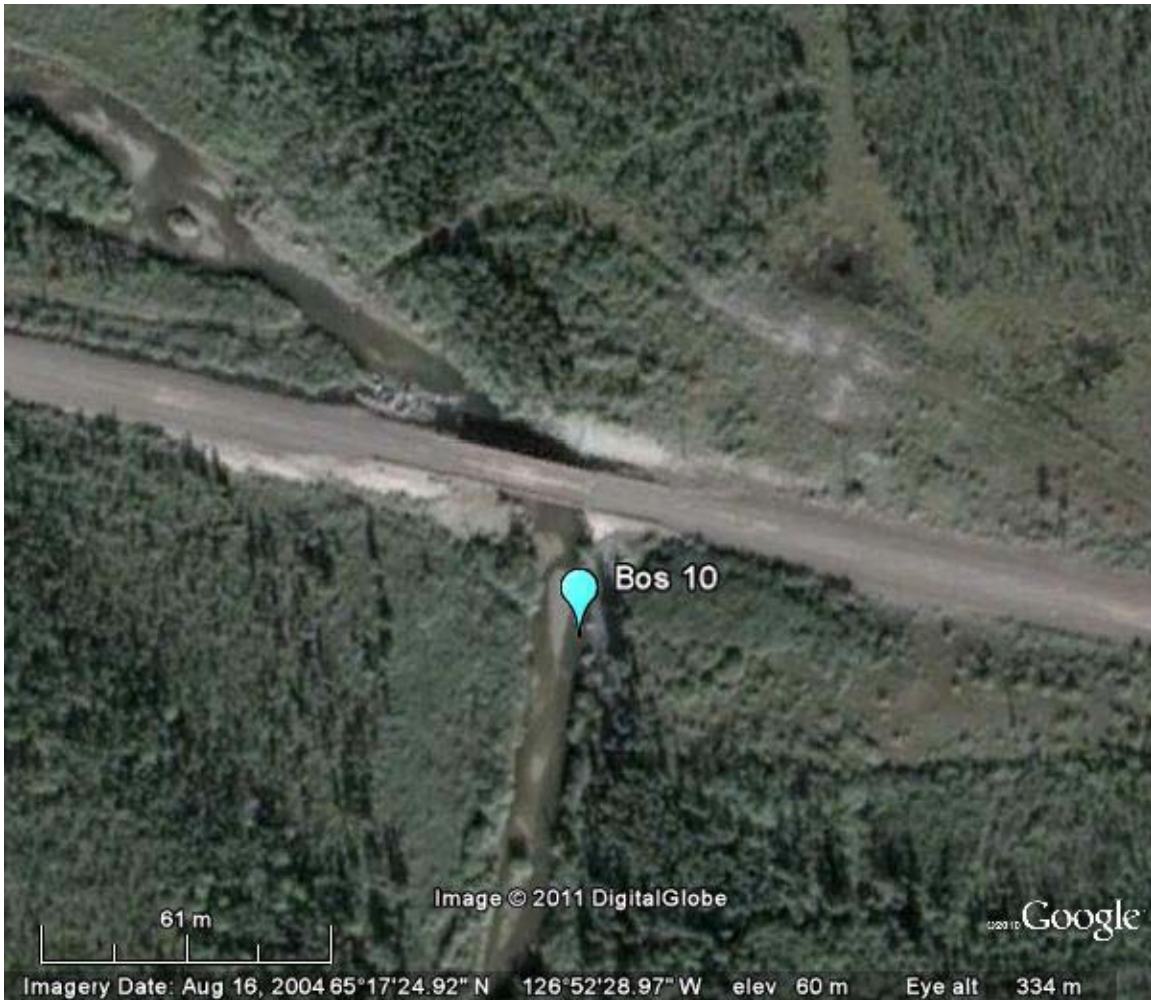
Figure 20. South of Upper Bridge site sample location (Image Source: Google Earth 2011)

One sample (Bos 10) was collected directly downstream of the upper bridge by INAC in the summer of 2009 (Figure 20). There is limited data from this site; however, there are no exceedances of the GPAL or GCDWQ.

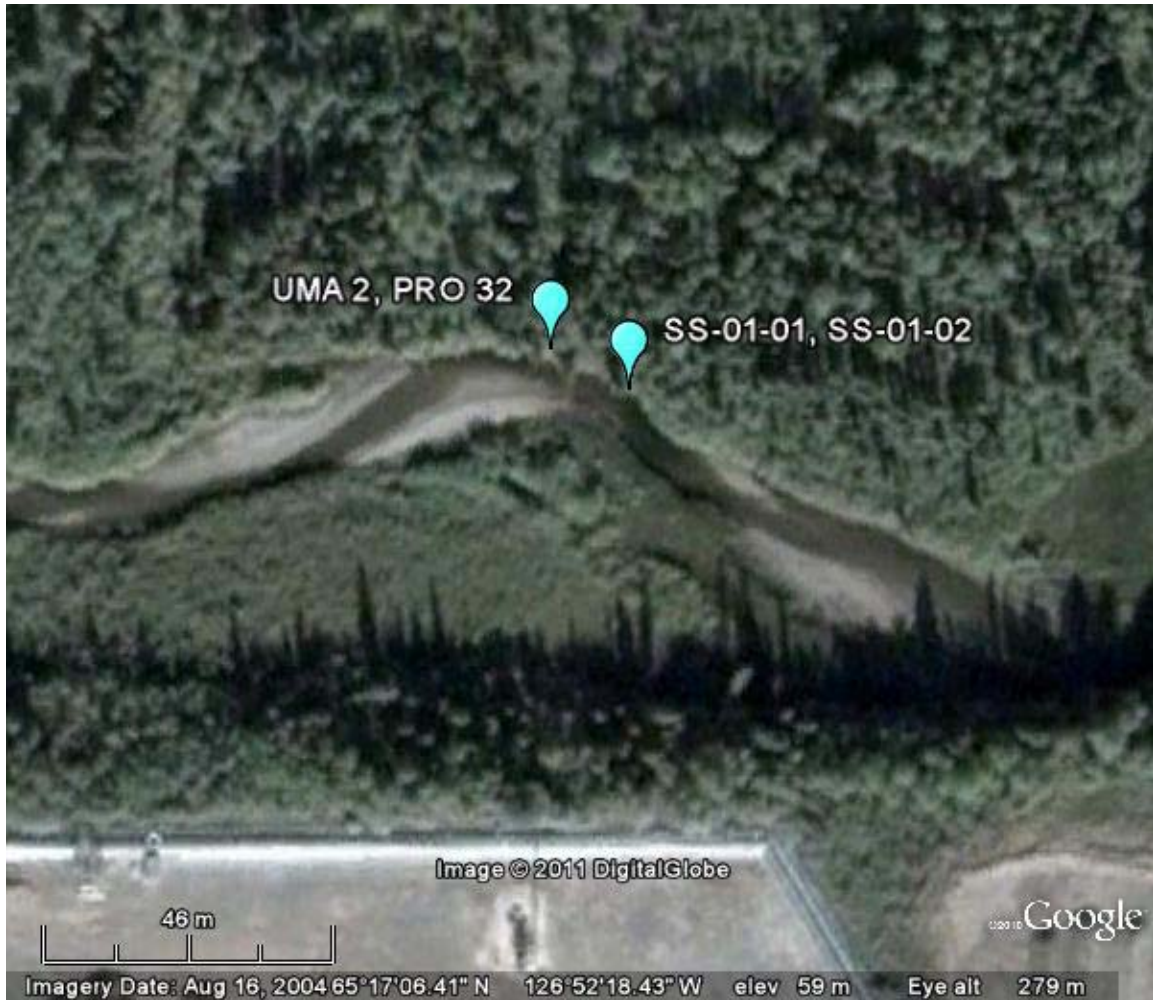
Figure 21. Upstream of Reservoir site sample location (Image Source: Google Earth 2011)

There are four sample sites located upstream of the former reservoir that existed until the removal of the weir in 2005 (Figure 21). These sites include one sample from the period when the weir was in place (UMA 2) and three samples from the BCMP (PRO 32, SS-01-01, SS-01-02) from August 2008.

Table 14 shows the chemistry data from this site that exceeds either the GCDWQ or GPAL. Most of the exceedances of the guidelines for drinking water and protection of aquatic life at this location are caused by the impact of one sample, SS-01-01, taken on August 9, 2008. This site is a small spring on the north shore of Bosworth Creek (Figure 22), which was first identified in the summer of 2008 (Guthrie 2009). This sample has an extremely high aluminum concentration of 76 mg/L, much higher than the 0.1 mg/L GCDWQ and GPAL; cadmium concentrations are 0.002 mg/L, exceeding the 0.000017 mg/L GPAL; chromium concentrations of 0.16 mg/L exceed both the GCDWQ (0.05 mg/L), and GPAL (0.0089mg/L); copper at a concentration of 0.14 mg/L exceeds the 0.004 mg/L GPAL; the lead concentration of 0.107 mg/L is substantially higher than the 0.01 mg/L and 0.007 mg/L guidelines for water quality and protection of aquatic life, respectively; nickel concentrations of 0.27 mg/L are almost double the 0.15 mg/L

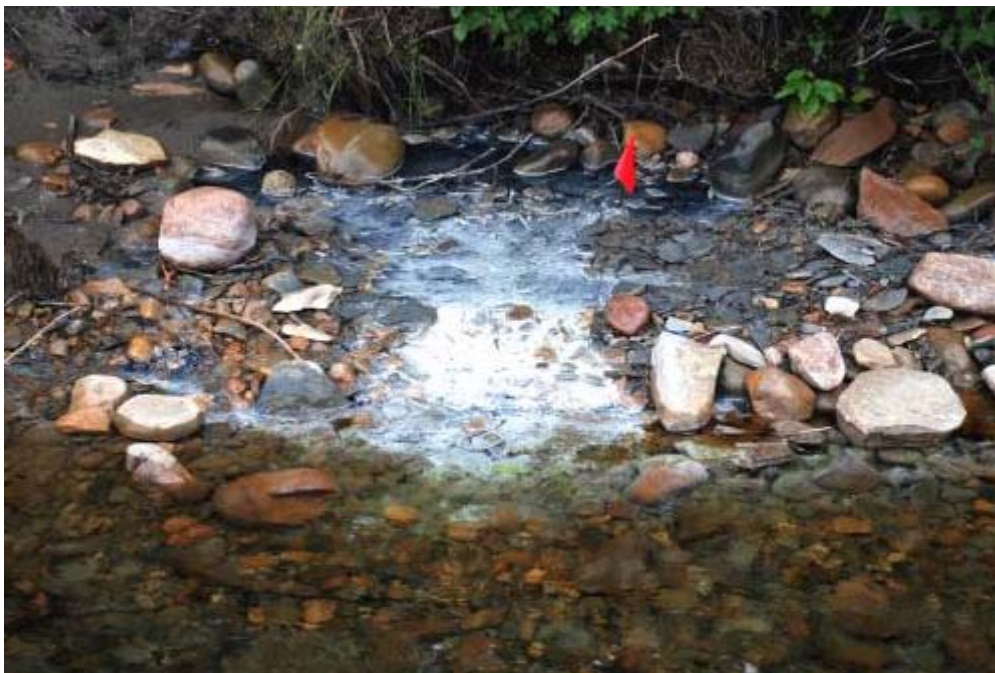
Figure 22. Site of Sample SS-01-01, a small spring on Bosworth Creek (Source: Guthrie, 2009)

guideline for the protection of aquatic life; selenium at 0.005 mg/L exceeds the guidelines for aquatic life (0.001 mg/L); the thallium concentration of 0.003 mg/L exceeds the 0.0008 mg/L guideline for protection of aquatic life; zinc at a concentration of 1.71 mg/L is greater than the guideline of 0.03 mg/L for the protection of aquatic life, and an iron concentration of 202 mg/L is many orders of magnitude greater than the 0.3 mg/L guideline for both drinking water quality and the protection of aquatic life. Of all the samples in the Bosworth Creek dataset, this sample has the highest concentration of aluminum, arsenic, barium, cadmium, chromium, cobalt, copper, lithium, nickel, thallium, titanium, uranium, vanadium, zinc, calcium, potassium, magnesium, and iron.

With the exception of the SS-01-01 sample, the only other exceedances were aluminum and iron. The sample SS-01-02, another spring sample taken on August 20, 2008, exceeded the 0.1 mg/L guideline for both drinking water quality and the protection of aquatic life with a concentration of 0.49 mg/L. The PRO 32 sample taken the same day as the SS-01-02 sample had an aluminum concentration below the 0.01 mg/L detection limit. Iron concentrations in the SS-01-02 samples were 1.14 mg/L, greater than the 0.3 mg/L guidelines for both drinking water quality and the protection of aquatic life. The
