Bosworth Creek Water Quality
Data Study:

Final Report

Collins, L.A., C.D. Murray and R.T. Stainton. 2011.
Bosworth Creek Water Quality Data Study: Final Report
Environmental Studies Research Funds Report No. 185. Oshawa, ON. 69 p.

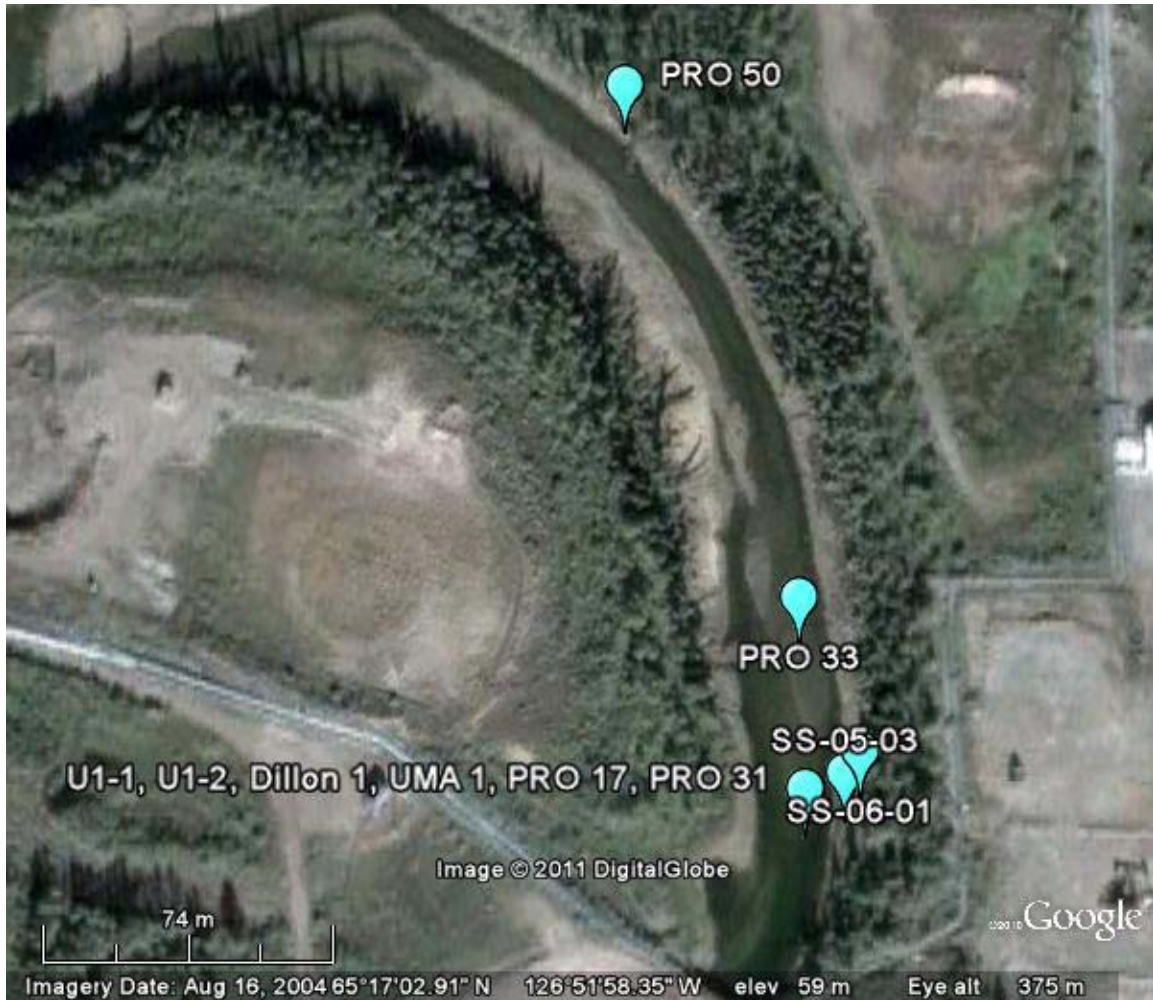
Figure 23. Lower Bridge North site sample locations (Image Source: Google Earth, 2011)

There are a total of 16 samples for the area north of the lower bridge crossing Bosworth Creek (Francl 3, Francl 4, Thomas 1, Thomas 2, Thomas 3, Thomas 4, Dillon 1, UMA 1, U1-1, U1-2, PRO 17, PRO 31, PRO 33, PRO 50, SS-05-03 and SS-06-01) (Figure 23). Historical samples from the town tap (Canol Camp) from Thomas (1957) are included in this set of samples, although exact location data is not available. These samples are from winter of 1954, and winter, spring and fall of 1956. Frankl (1974) samples are from winter and summer of 1970. There is one sample from spring of 1978 (Dillon, 1978), one sample from winter 1989 (UMA, 1989), and 8 BCMP samples from summer, 2006, fall 2007, summer 2008, and summer and fall of 2009. Samples from this region are considered together for statistical analysis. This region is just upstream of the former dam created at the lower bridge by Imperial Oil in 1960. This area was heavily impacted by the blockage of the creek by the weir as it is directly upstream of this location.

Table 15 shows the chemistry data from this site that exceeds either GCDWQ and/or GPAL. Of the 11 samples from this location that were analyzed for aluminum, 73% of them exceeded the 0.1 mg/L GCDWQ and the GPAL. The results show aluminum concentrations that range from a maximum of 14 mg/L at PRO 31 in August 2008, to a low of 0.033 at PRO 17 in July 2007. The average aluminum concentration at this site is 2.03 mg/L.

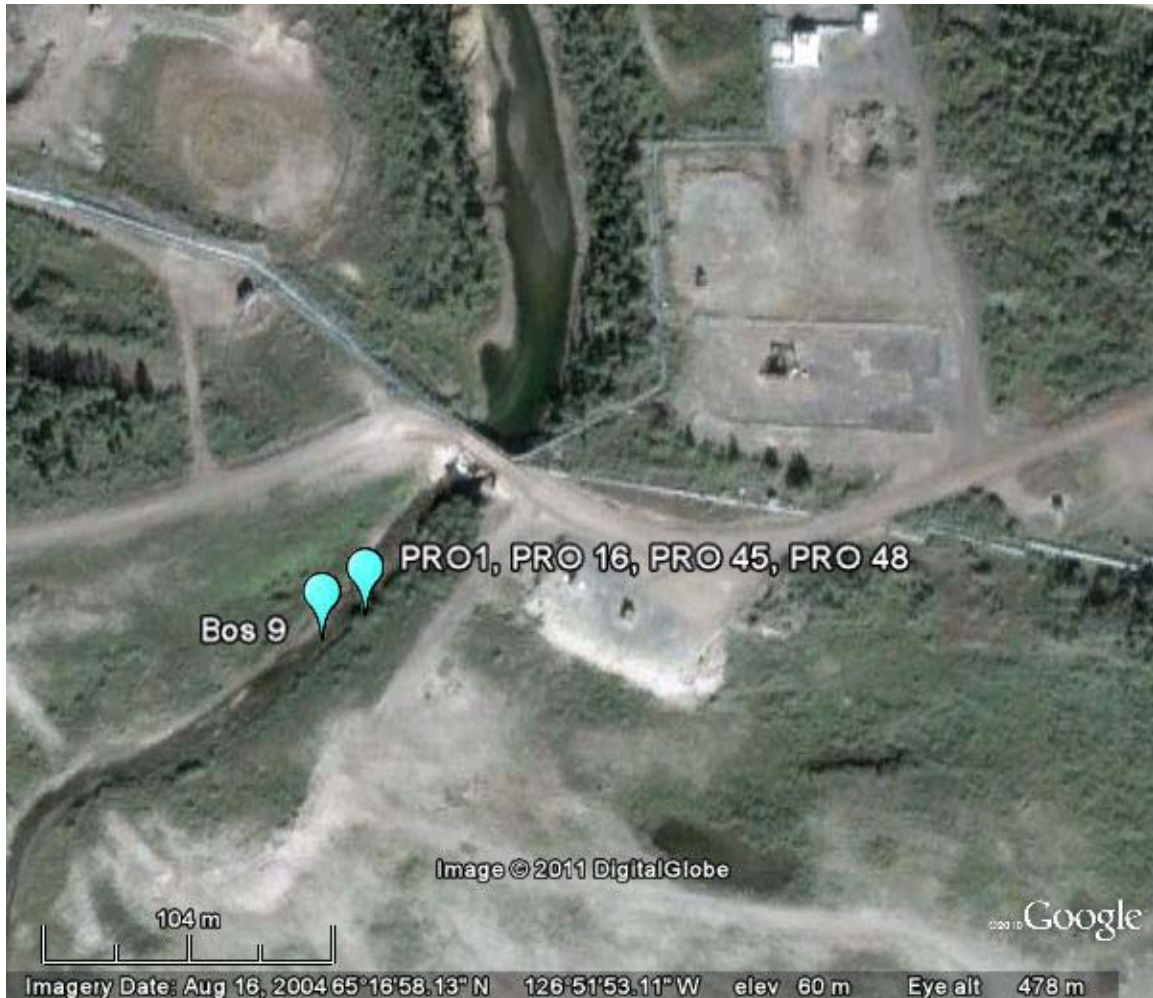
Figure 24. Lower Bridge South site sample location (Image Source: Google Earth, 2011)

This area was sampled five times and includes samples from both the BCMP and INAC sites (PRO 1, PRO 16, PRO 45, PRO 48, Bos 9) (Figure 24). Sampling dates range from winter (December) 2006, summer 2007, and spring, summer and fall of 2009. This region of the Creek has undergone significant changes over time from pre- to post-weir removal, including stream restoration, engineering and re-vegetation.

Table 16 shows the chemistry data from this site that exceeds either the GCDWQ or GPAL. Two samples exceed the 0.1 mg/L guidelines outlined by the GCDWQ and GPAL. Two samples exceed the 0.1 mg/L guidelines outlined by the GCDWQ and GPAL. Sample Pro 45 and PRO 48 had aluminum concentrations of 0.996 mg/L and 0.379 mg/L, respectively. These samples were taken in May and June of 2009. Samples taken in 2006 and 2007 had much lower aluminum values, with an average aluminum concentration of 0.022 mg/L. Sample PRO 45 had a copper concentration of 0.0067, which is above the 0.004 mg/L GPAL. The other three samples analyzed for copper were well below the guidelines. Only one sample out of four analyzed for mercury had a concentration greater than the detection limit. Sample PRO 16 taken in July 2007 had a mercury concentration of 0.00003 mg/L, above the 0.000017 mg/L GPAL. Selenium concentrations exceed the 0.001 mg/L GPAL in two of the three
